# Cordova Main Post Office in Cordova, TN: Delivery Unit Operations

## AUDIT REPORT

Report Number 23-100-2-R23 | June 27, 2023

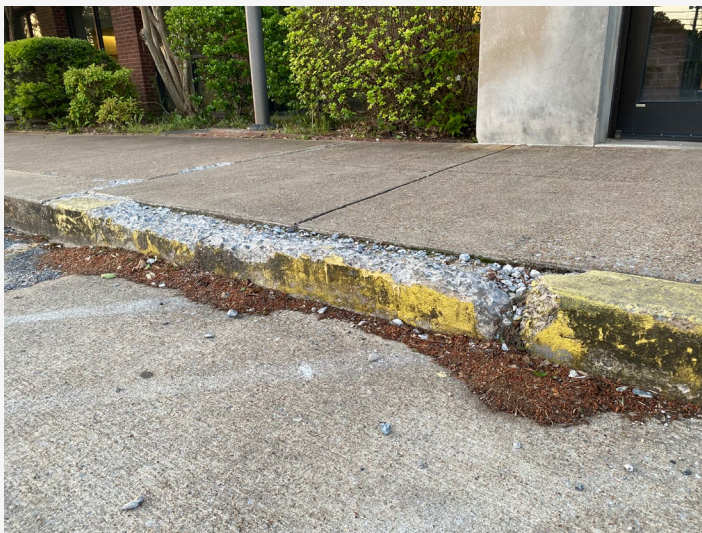
**Figure 1. Crumbling Sidewalk Concrete**

- An Inspection Service door was blocked by miscellaneous materials, including an unsecured step ladder.
- All five fire extinguishers on-site were missing updated monthly and annual inspections.
- No manual fire alarm pulls observed in the facility.<sup>21</sup>
- Numerous electrical cord daisy chains were observed on top of carrier cases.
- Crumbling concrete curb and sidewalk cracks were observed at the front of building (see Figure 1).
- Loading dock guard rail was damaged with bent and exposed metal edges.

*Property Conditions:* Seven of the 18 property conditions have been abated. Work orders have been submitted for the remaining 15.

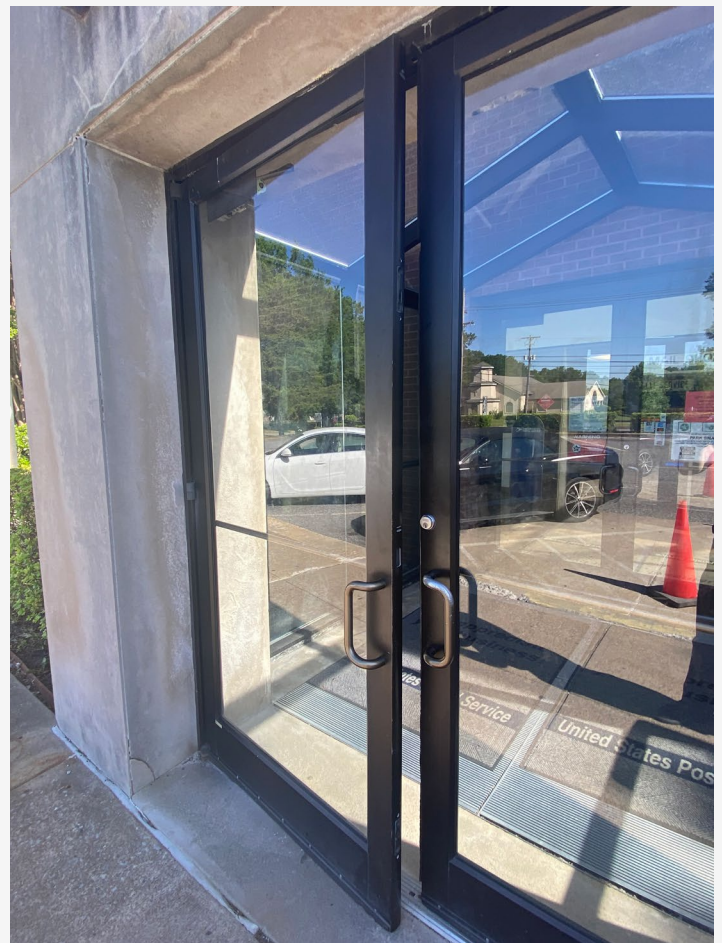
**Figure 2. Customer Lobby Door**

- No “subject to search” sign posted on property.
- Outermost customer lobby glass door did not close properly (see Figure 2).
- The employee parking lot gate was not working and has damaged concrete pylons (see Figure 3).

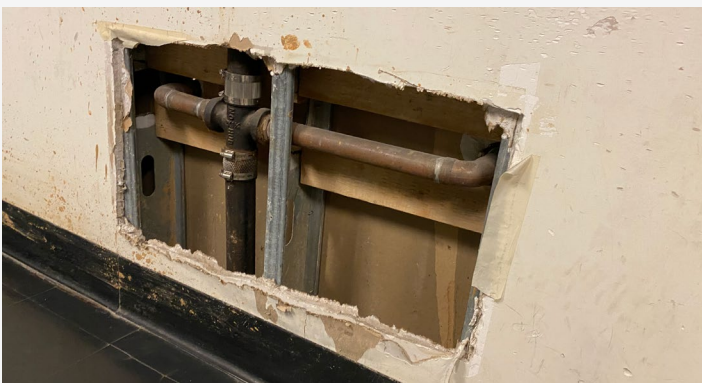
**Figure 4. Men’s Bathroom Wall Damage**

- Wall damage and cut-out in the men’s restroom (see Figure 4).
- Numerous stained, damaged, or missing ceiling tiles throughout the facility due to roof leaks, including the customer lobby.
- Some parking lot lights (employee and customer parking lots) were burnt out, while other lights were on.
- One loading dock platform was out of order.
- The workroom water fountain was not functioning and blocked off (see Figure 5).
