Germantown Main Post Office in Germantown, TN: Delivery Unit Operations

AUDIT REPORT

Report Number 23-100-4-R23 | June 27, 2023

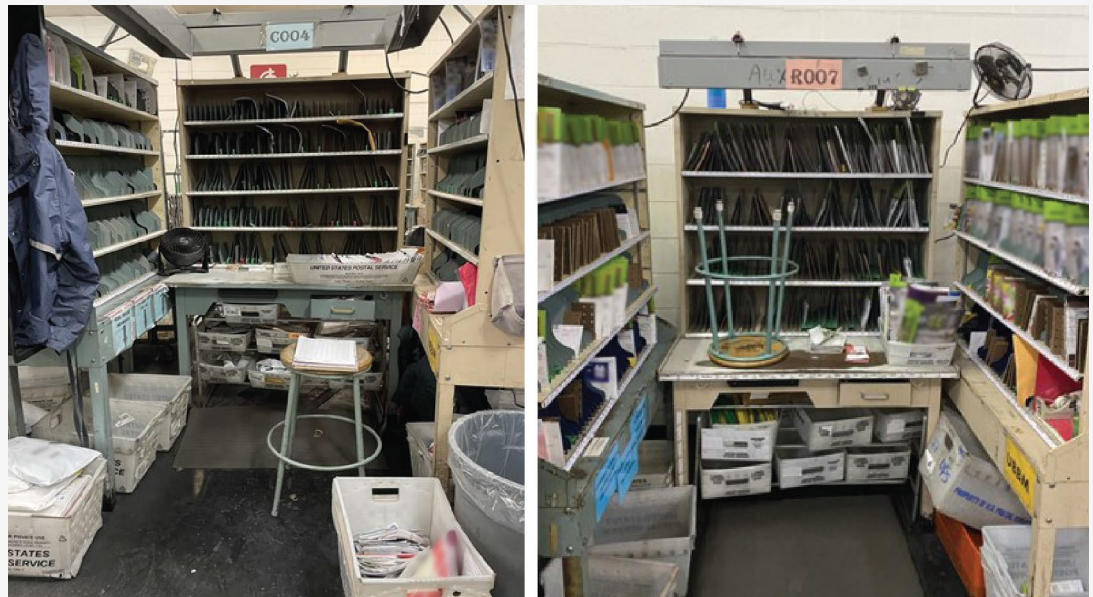
Figure 1. Examples of Delayed Mail in the Carrier Cases

On the morning of May 2, 2023, we identified about 2,546¹¹ delayed mailpieces at 24 carrier cases. Specifically, we identified about 1,155 flats and 1,391 letters. Much of this mail was taken out for delivery the previous day and brought back but was not identified with a Postal Service (PS) Form 1571, *Undelivered Mail Report*. In addition, management did not report this mail as undelivered in the Delivery Condition Visualization (DCV)¹² system. See Table 2 for the number of delayed pieces for each mail type and Figure 1 for examples of delayed mail found at carrier cases.

Management should have ensured that all mail was processed and delivered daily and that any mail returned from a route was properly identified. Postal Service policy¹⁴ states that all types of First-Class Mail, Priority Mail, and Priority Mail Express are always committed for delivery on the day of receipt. In addition, managers are required to report in DCV all mail that remains in a unit after the carriers have left for their street duties.¹⁵

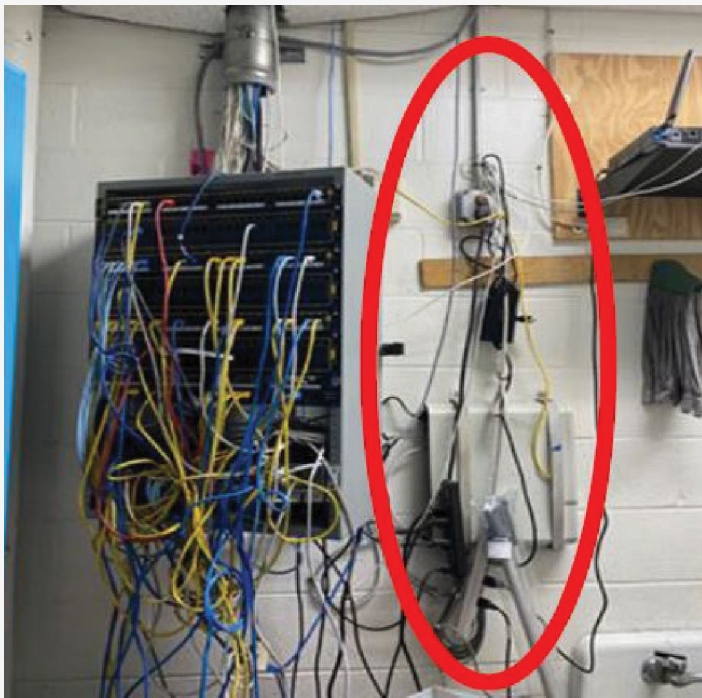
Figure 2. Multiple Cords in Server Room Plugged into Power Strips

- Missing monthly inspections for all eight fire extinguishers. Also, one extinguisher was not mounted.
- Multiple cords plugged into power strips, near a water source, in the server room (see Figure 2).
- A portable heater located behind the counter in the retail lobby that was plugged into an extension cord (see Figure 3).
- Large potholes in the rear parking lot (see Figure 4).

Management did not take the necessary actions to ensure that facility condition issues were corrected. Specifically, the acting postmaster had only been at the unit for about two months and was not aware of some of the issues we identified, including the unmounted fire extinguisher, the multiple cords plugged into power strips, the doors that could not be locked, the blocked Inspection Service doors, the unsecured ladder, and the blocked electrical panel. In addition, he was not aware that fire extinguishers required monthly inspections. Management reported the potholes in the electronic Facilities Management System (eFMS) on March 15, 2023. As of May 17, 2023, management was waiting on a quote to repair the parking lot. The acting postmaster was also aware of the large hole in the front lawn but did not know that it was a safety hazard.

Management should have provided sufficient oversight of facility maintenance; reported safety, security, and maintenance issues as they arose; and followed up to ensure resolution. The Postal Service is required to maintain a safe environment for employees and customers. In addition, the Occupational Safety and Health Administration (OSHA) requires employers to provide a safe and healthy workplace free of recognized hazards.²⁵

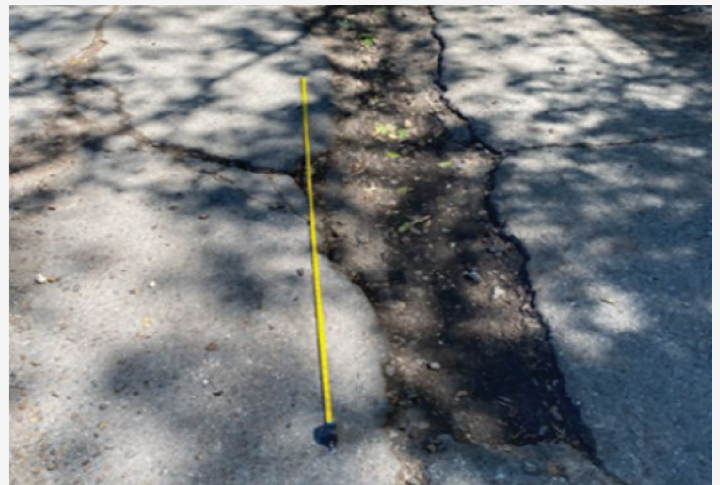
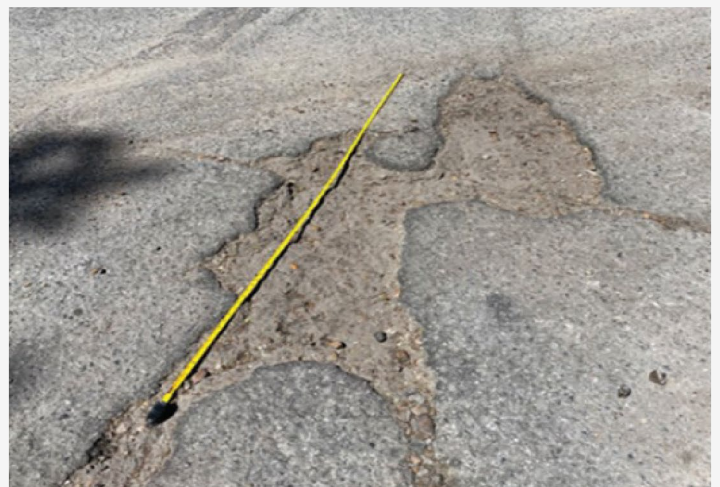
Figure 4. Large Potholes in the Rear Parking Lot

Source: OIG photos taken on May 3, 2023. For reference, a six-foot tape measure was used to measure the potholes.

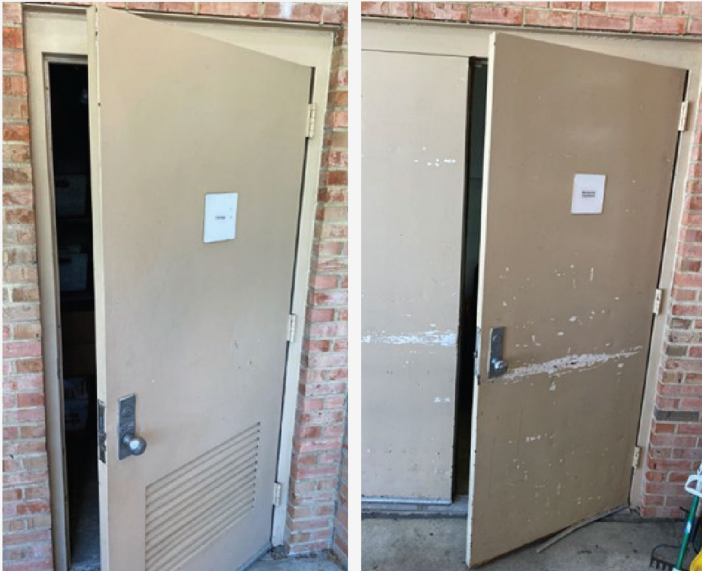
Figure 5. Doors to the Electrical/Furnace Room Could Not Be Locked

- Doors to the electrical/furnace room and storage room located on the loading dock that could not be locked (see Figure 5).

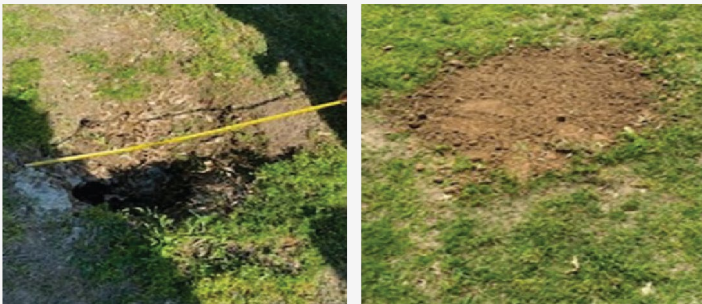
Figure 6. Hole in the Front Lawn

- A large hole in the front lawn (approximately 20" wide by 15" deep) (see Figure 6).
- Two blocked U.S. Postal Inspection Service doors.
- One unsecured ladder.
- One blocked electrical panel.

Source: Photo provided by Germantown MPO Management on May 9, 2023.
